Keynote: Concertgebouw Amsterdam: History of the main hall and its acoustics; PART 2: Preserving the acoustics

Martijn VERCAMMEN¹; Margriet LAUTENBACH²; Rob METKEMEIJER

Peutz, The Netherlands

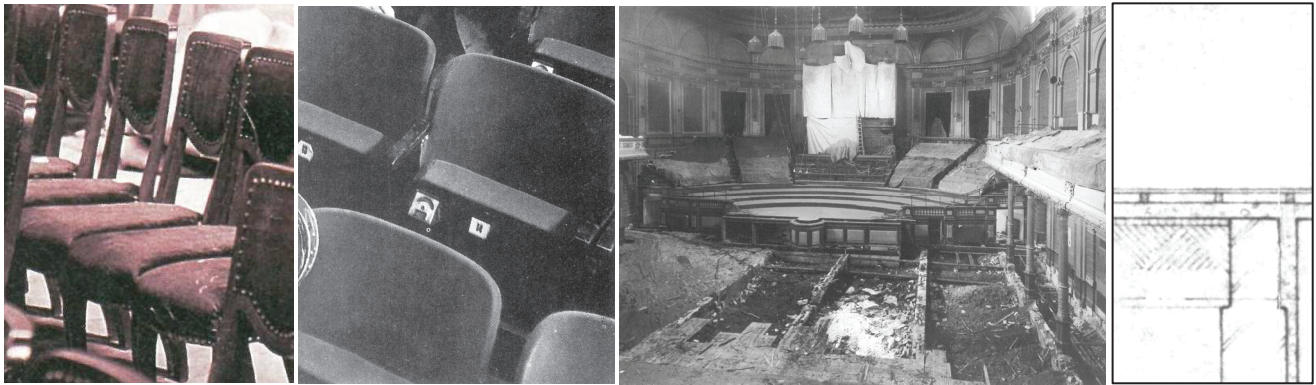
In 1938 the seats on parterre were replaced with more comfortable seats with more absorption, especially when unoccupied (fig.1).

In 1947 it was discovered that the wooden floor construction was damaged by perennial fungus. A new floor construction was made with concrete, 40 mm of sand and a new wooden floor above this (fig. 1). Of course this was a risky operation, as it could change the low frequency absorption of the floor. Apparently after this change, the hall was as good as before, maybe even better (5).

Figure 1. From left to right: original seats, seats in 1938, renewal of the floor in 1947, section after renewal

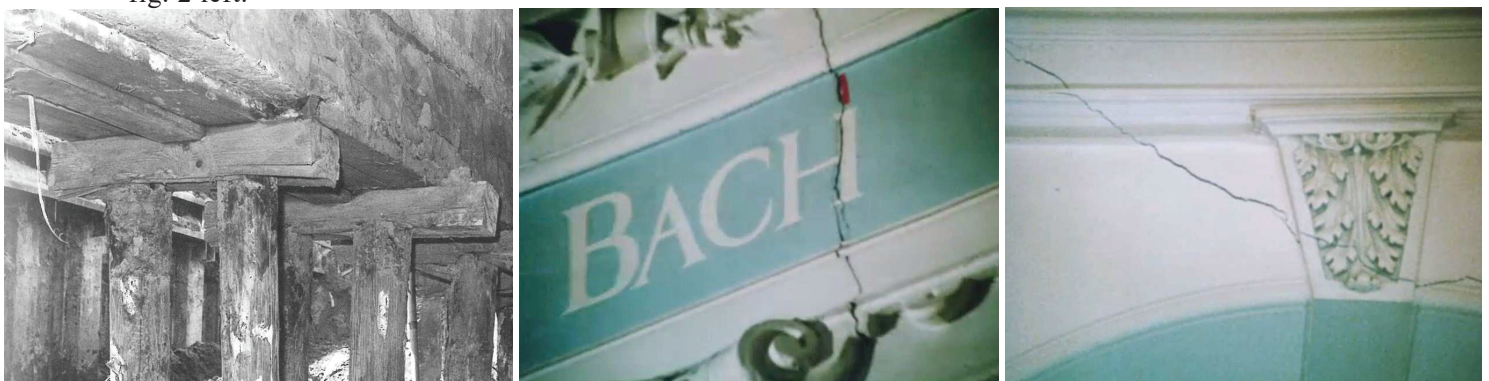
At that time it was common for foundations to be made of wooden piles driven into the soft soils. These foundations can hold for very long, provided the wood remains under the ground water level. The foundation of the Concertgebouw consists of pairs of wooden piles, connected by a capping, see fig. 2 left.

Figure 2. The wooden piles with capping under the building and the cracks in the walls

Around 1976 they started monitoring to investigate the sinking of the walls. In 1983 the alarm bells started ringing. The difference in setting was 18 cm and the speed of (unequal) sinking was such that short-term renovation of the foundation was necessary.

There were multiple reasons for the sinking. The load of the walls of the hall was higher than that of the other walls and was further increased by the introduction of the heating system from Leipzig, by doubling the walls after the piles were already driven into the soil. Moreover, some piles were not driven deep enough and there might have been variations in ground water level in the 19th century.

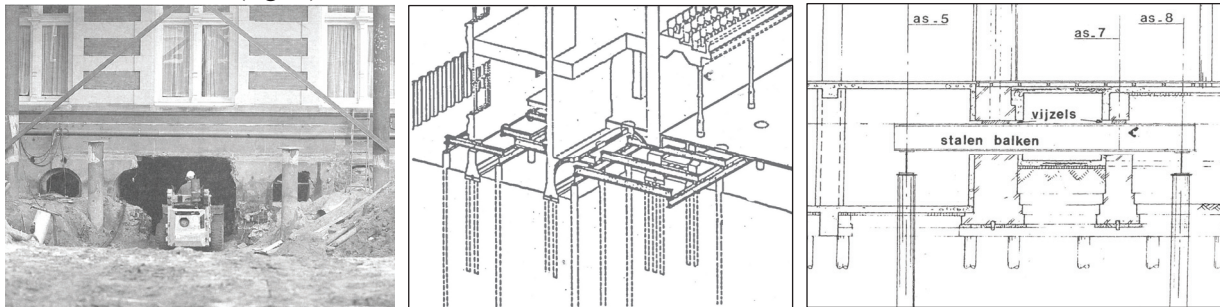
Figure 3. Renovation of the foundation (Strukton)

The new foundation was made with a specially adapted machine. The ground under the hall was removed until just above the cappings of the wooden piles. On both sides of the existing foundations, steel pipes of 1.8 metres were screwed into the soil. After it was driven into the soil, a next steel pipe segment was welded onto it and so forth, to a total length of about 18 m. Only in the main hall a short holiday break was used to drive in much larger elements from above the floor of the main hall itself (fig. 4).

After filling the steel pipes with concrete, steel beams were made through the existing foundation and supported by the new piles. These beams were then raised to support the old building (fig.3). After the whole building was supported by the new piles, the existing foundations were removed and a new basement was made, cutting the new piles at the right height.

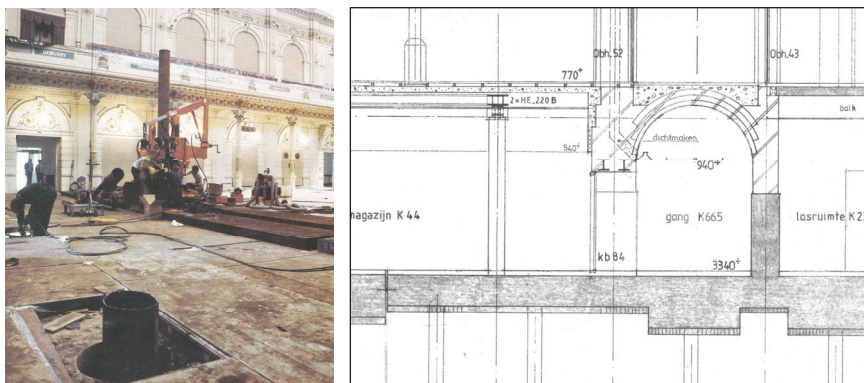
Figure 4. Left: Pile drilling in the main hall (2), right: section of the new situation

The concrete floor from 1947 with sand on top of the concrete was maintained. From the new basement, this existing concrete floor was supported with a steel construction. A few phases earlier, the steel piles were driven in through this floor. The holes in the floor were closed again, to make it as it was. A gypsum board ceiling was added below the concrete floor.

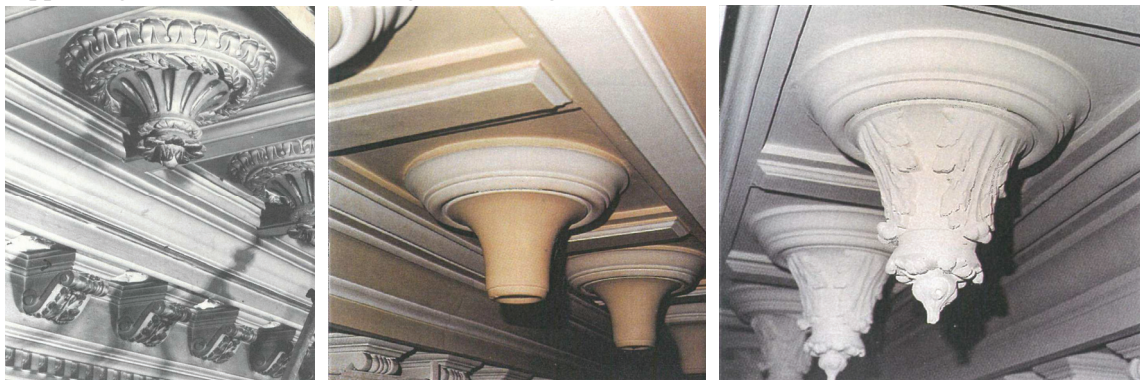
The cassettes in the ceiling had lost their original ornamentation in 1962. In 1998 this was brought back; it was partly original (with the original moulds), partly a new interpretation. The centre elements (called “flower pots”) were given a new ornamentation (nicknamed “lettuce crops”). The supporting construction was changed resulting in a small increase of surface mass.

Fig. 7. Ornamentation edge of ceiling, Left: original; middle: 1962, right: after renovation 1998 (9)

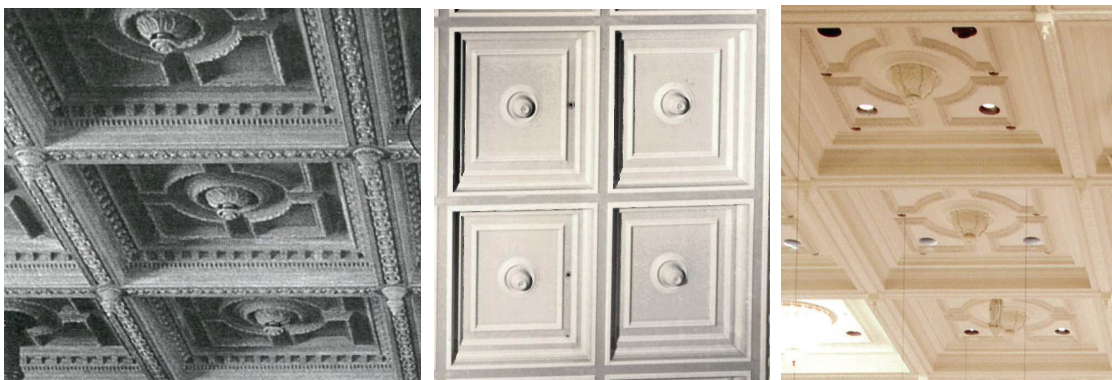
Fig. 8. Ornamentation of ceiling, Left: original; middle: 1962, right: after renovation 1998 (9)

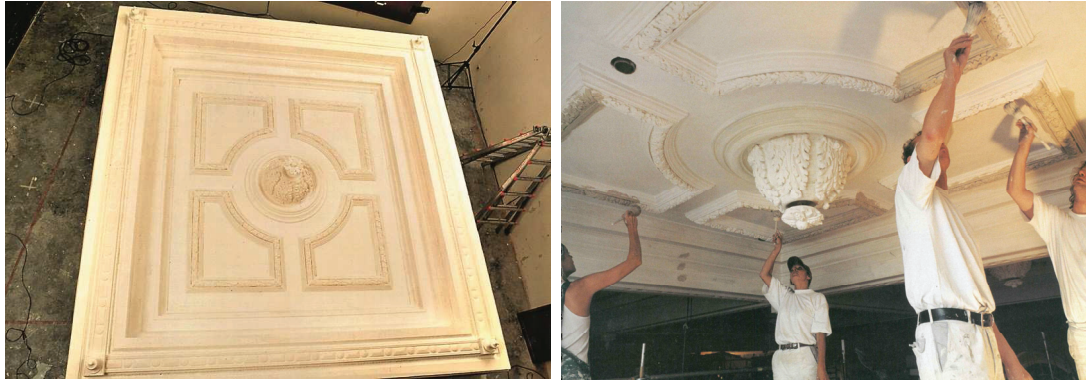
The effect of the change was expected to be very small. The requirement regarding reverberation time was that changes should remain within ± 0.1 s. which corresponds to about 50 m^2 of absorption. To be sure that it would not cause a measurable or audible change, a 1:1 scale model was made (fig.9) and tested in the Peutz Laboratory. Arup Acoustics was asked to give a second opinion.

Figure 9. Left: A sample of the ceiling cassette in the laboratory and right: during construction

The sound absorption remained unchanged (≤ 0.01); only at 63 Hz octave band was the absorption coefficient reduced by about 0.02, which is smaller than the repeatability in this frequency band (which is below the lower frequency of 100 Hz in the ISO 354).

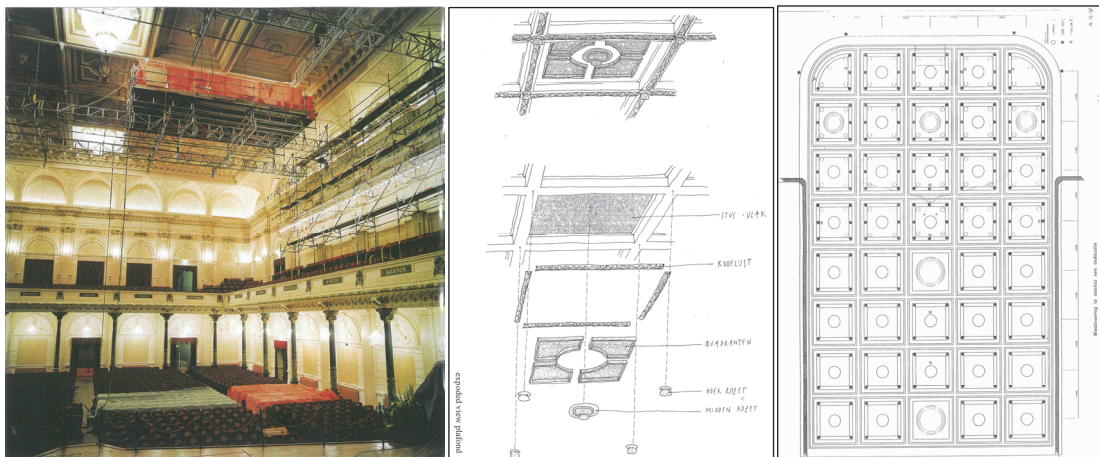
Figure 10. Left: The main hall in 1998 during renovation (8), Middle: Changes to the ceiling and Right: new ceiling plan with hoist openings (9).

Again this renovation was performed with the hall in use. A scaffold was built on top of the side balconies and connected by a bridge construction under the ceiling (fig.10). There was even a CD recording made in this situation. The work was done within four months time and mostly at night. (9) .

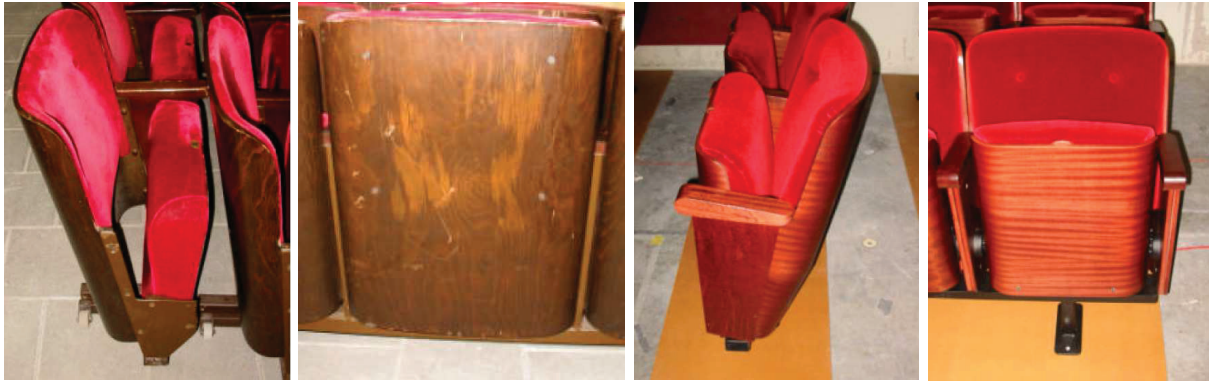
Figure 11. Seats before (left two) and after exchange (right two) in 2004.

In 1994 the seat cushions were renewed and five years after renovating the hall, in 2003/2004, this renovation was finalised with the replacement of the seats (fig. 11). They were a copy of the seats from 1938/1981, see also paragraph 3.1. The number of seats was slightly reduced because of increased row distance. At the balcony both row distance and height differences were increased. The increase of absorption by the modified seating arrangement on the balcony was calculated to have an

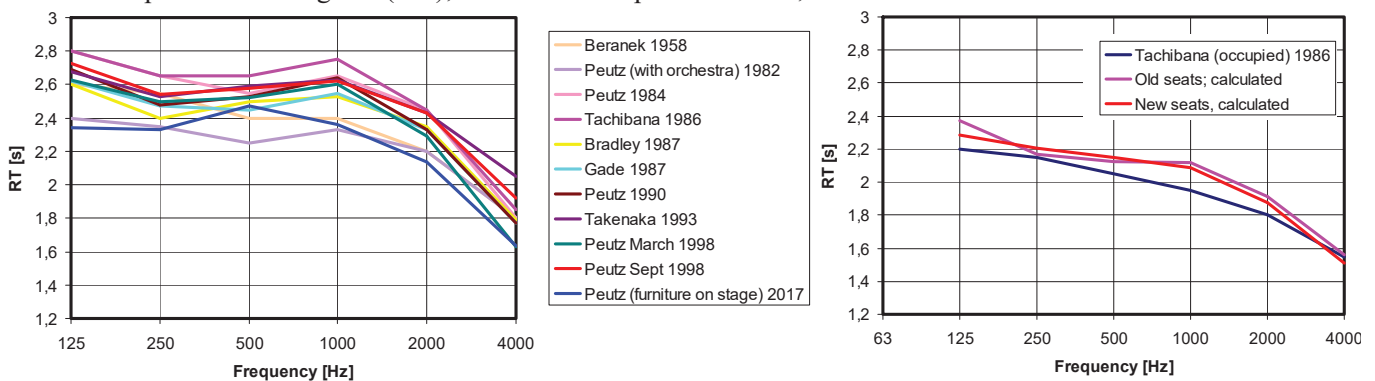
Figure 12. RT in the Concertgebouw, a.o. from (6) and (11), left: unoccupied, right: occupied

- The 1982 measurement shows a significant influence from the orchestra.
- The measurements just before and just after the renovation of the hall in 1998 show no change in the octave bands 250 - 1kHz. At 125 Hz an increase of slightly less than 0.1 s. is measured. At 2 and 4 kHz an increase of 0.1-0.2 s. was measured. This was expected to be a temporary effect due to cleaning the hall.
- The 2017 measurements show a shorter RT in the unoccupied situation. This is due to the furniture on stage (previous measurements are with an empty stage except for the 1982 measurement) and increased sound absorption of the seats in the unoccupied situation. Laboratory measurements on the existing and new seats in 2003 showed more or less the same absorption in the occupied situation but an increase of absorption in the unoccupied situation.
