# Influence of Hall Geometry on Balance: example of an orchestra rehearsal room

# INFLUENCE OF HALL GEOMETRY ON BALANCE - EXAMPLE OF AN ORCHESTRA REHEARSAL HALL

## 2. THE ORCHESTRA REHEARSAL ROOM

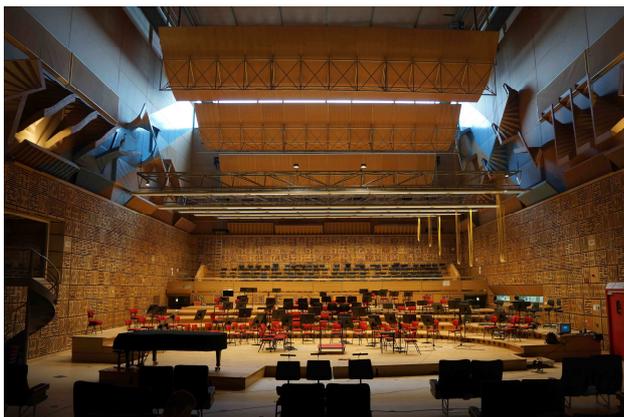
**Figure 3.** An overview of the orchestra rehearsal room in 2017.

The hall itself has a rectangular shape of 45 x 21 x 17m

(l x w x h) and therefore volume of about 16,000 m<sup>3</sup>. There were no additional stage walls, but there were 3 rather curved reflectors above stage at a height of about 10m. The wall directly behind the stage (the wall of the orchestra tribune) is slightly curved and reflective.

The walls of the rehearsal room are made of perforated elements behind which there is in the cavity either diffusion or absorption. Only at the sides of the stage the perforation has been closed.

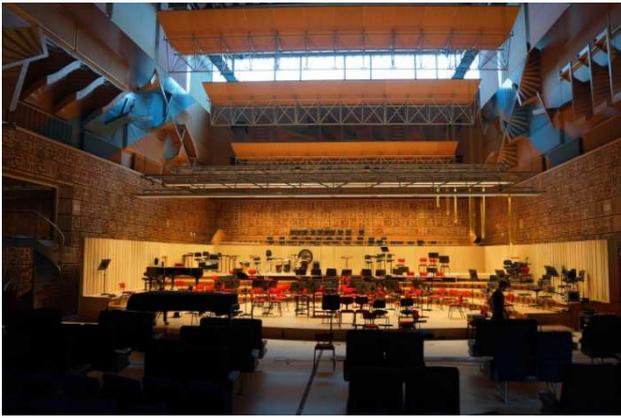
**Figure 4.** An overview of the orchestra rehearsal room in 2020.

- a new stage layout of 18 x 12m. Due to practical reasons the depth has been increased to 13,5m;
- new reflective stage side walls of a height of 2,5m at the sides of the stage, so closer to the musicians than the walls of the hall;
- a basically flat stage rear wall (between stage and choir) instead of the curved one;
- both stage rear and side walls have a scattering shape, zick-zack for the side walls, with added laths for fine diffusion and cylinder shaped convex diffusors on the stage rear wall;
- the existing reflectors are now at a 0° position;
- about 85 second-hand chairs leftover from a theater renovation have been added to the "audience" area;
- awaiting more absorbing chairs, the roll curtains have been rolled out completely.
